K2 Wind Ontario LP K2 Wind Power Project Built Heritage and Cultural Heritage Landscape Assessment February 2012

**CULTURAL HERITAGE RESOURCES: BARNS AND OUTBUILDINGS**

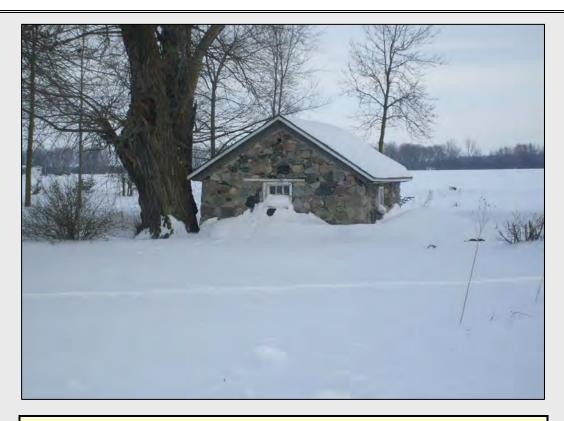
RECORD NO. B01

DESCRIPTION Stone milk house, Lot 10, Concession 1, E.D., Ashfield

This small outbuilding was probably built as a milk house. The fieldstone construction would have allowed the milk to remain cool is warm temperatures.

The building retains its heritage character, but many of the associated farm buildings have been removed and the associated farmhouse is in disrepair. It is the only milk house recorded during the field study.

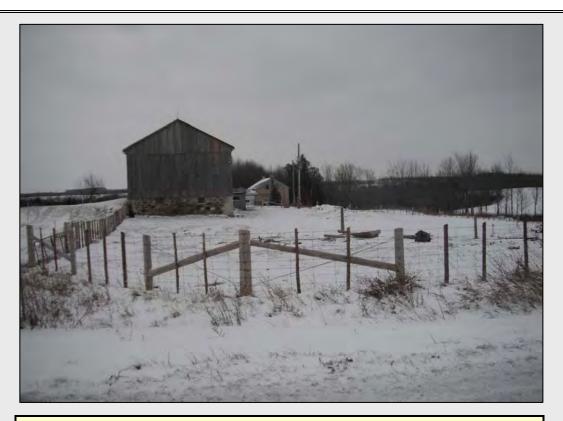
RECORD NO. B02

DESCRIPTION Nixon Farm, Lot 10, Concession 11, E.D., Ashfield

This gable barn was probably built in the 1860s or 1870s. It has a fieldstone foundation and is likely a typical three-bay timber framed structure.

This is a well-preserved example of a confederation period barn. The situation and heritage character of this building is intact.

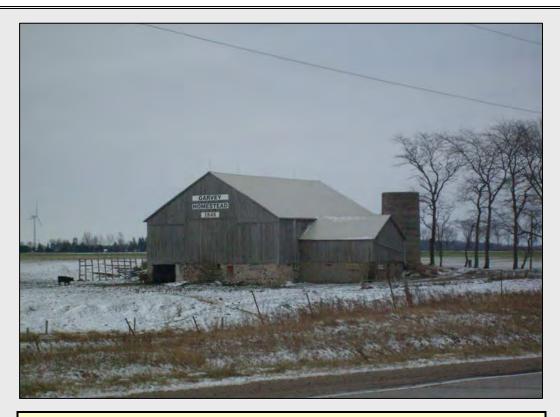
RECORD NO. B03

**DESCRIPTION** Garvey Barn, Lot 4, Concession 5, W.D., Ashfield

This structure is a large gable barn. Its present configuration was built in at least three phases, being the eastern portion, identifiable by the foundation formed by large, dressed fieldstones, the middle portion, identifiable by the rubblestone foundation, and the westernmost section, identifiable by the concrete foundation. The earliest section is likely that with the rubblestone foundation.

In spite of some later additions and modifications to this barn, it retains its heritage character and is associated with a nineteenth-century house that is part of the the existing farm (H19).
